East Teshekpuk No. 1 Well Plugging – 2008

Operations Summary

East Teshekpuk Well No. 1

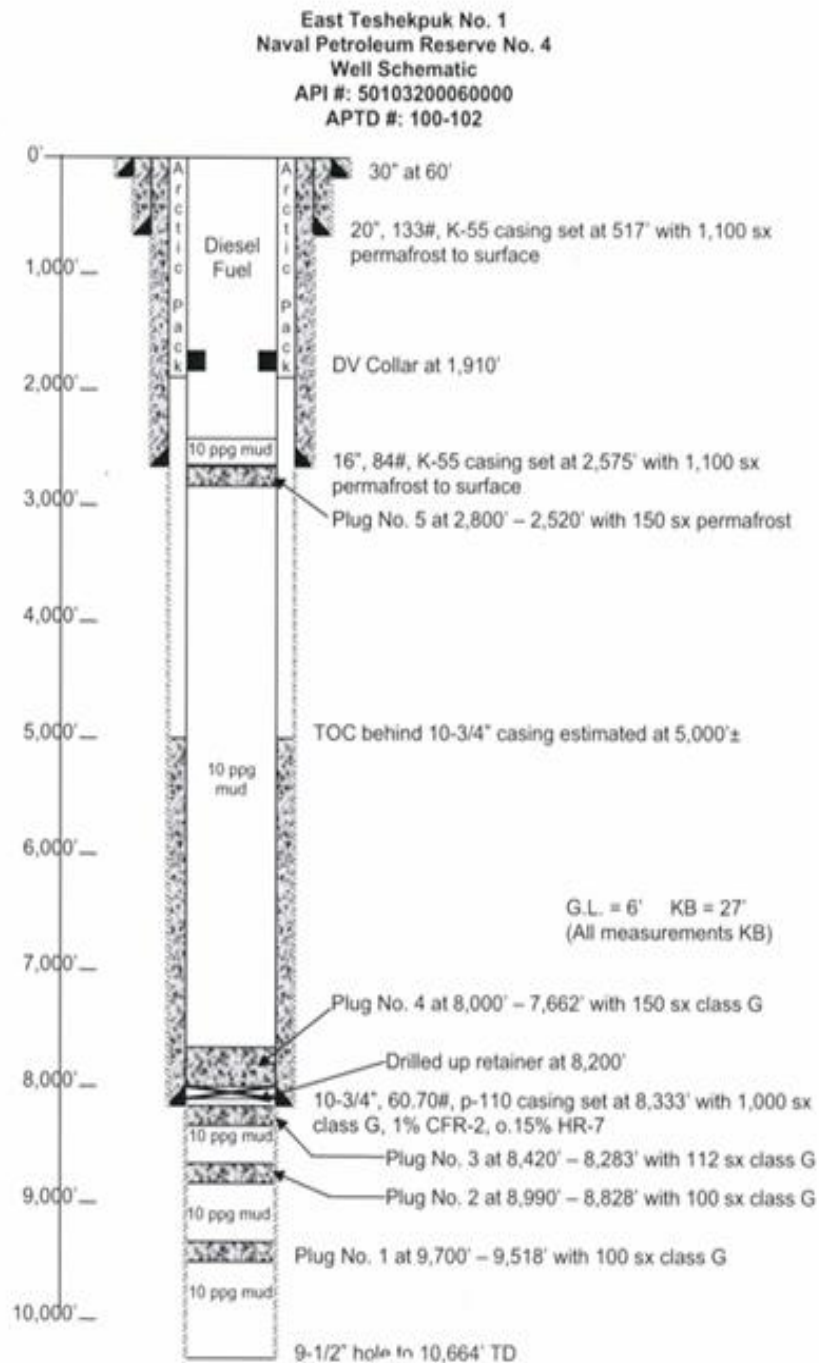
Figure 2: East Teshekpuk No. 1 Well – July 2007 Status

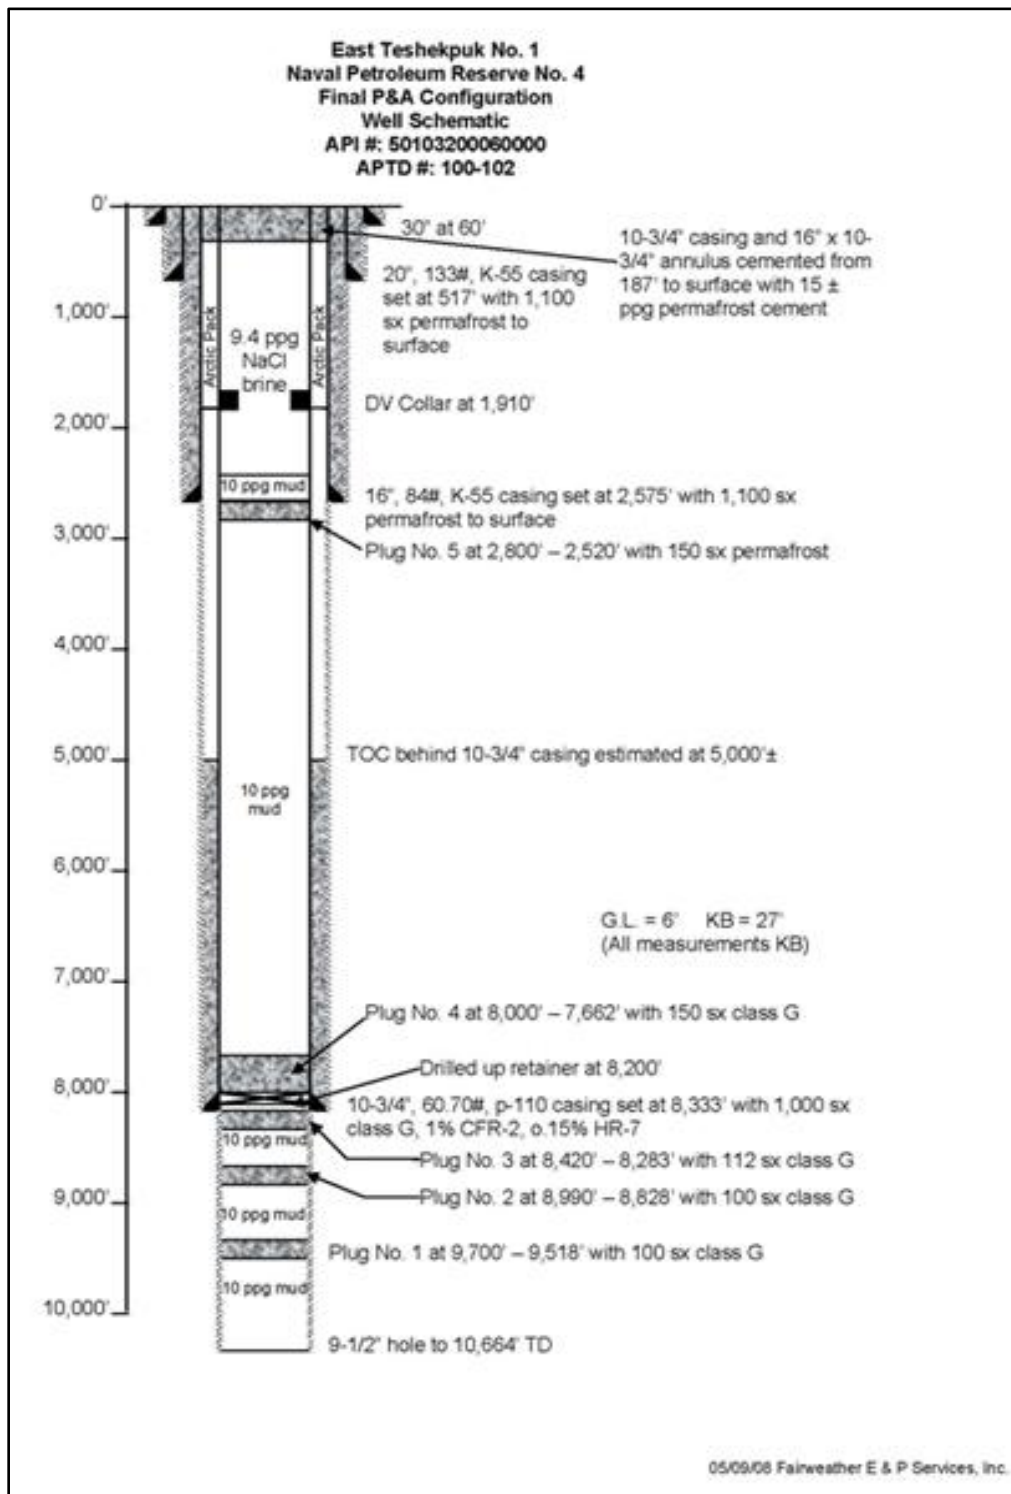
Figure 3: East Teshekpuk No. 1 Well – FINAL P&A Configuration

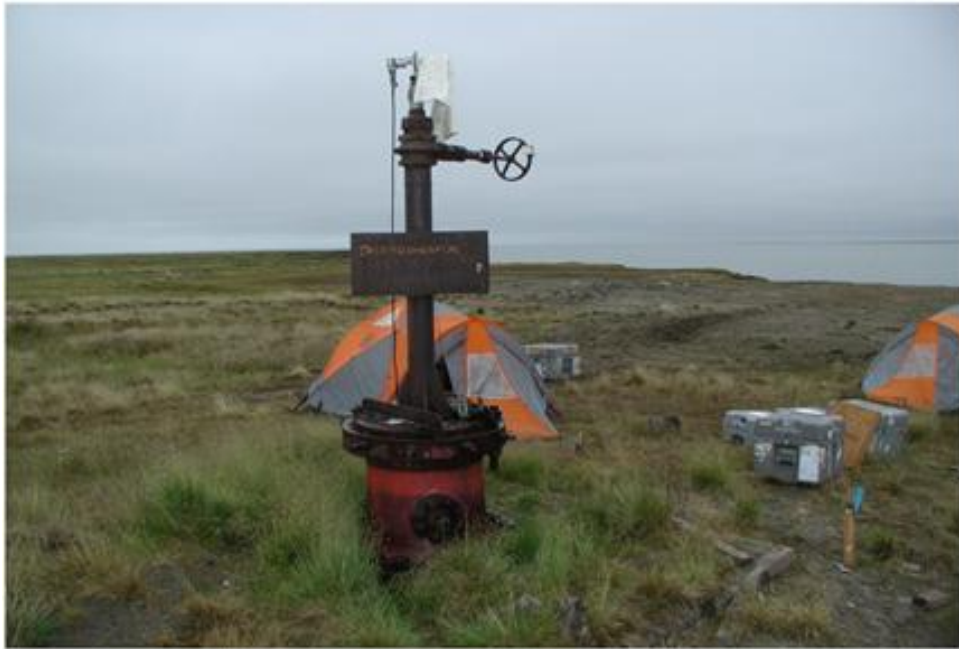
Figure 4: East Teshekpuk No. 1 wellhead during the summer of 2006

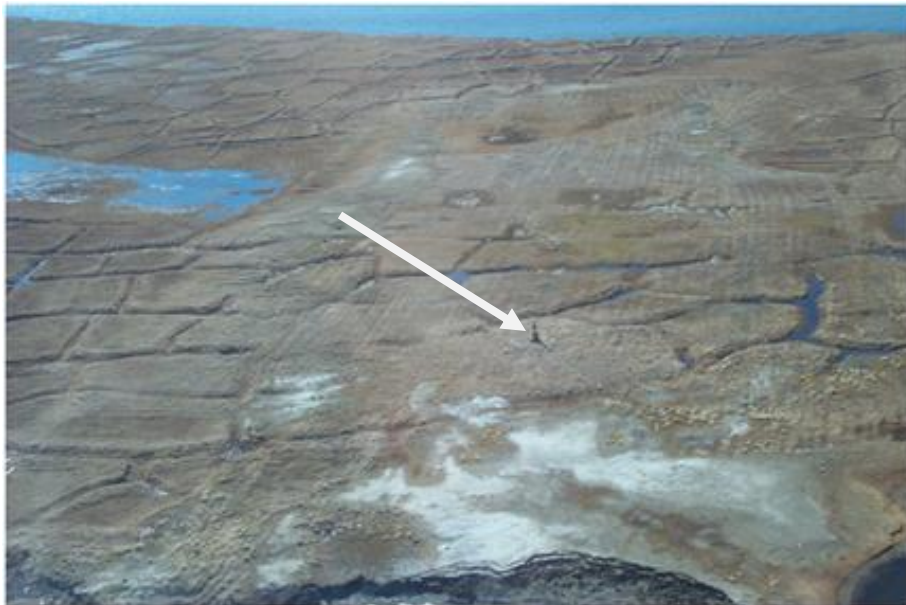
Figure 5: East Teshekpuk well location – July 2005

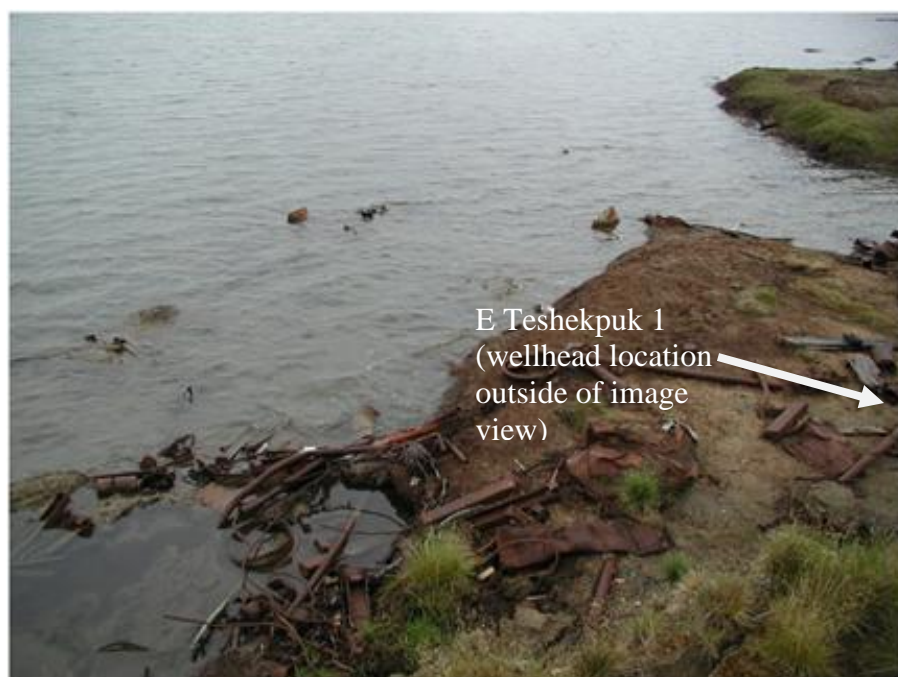
Figure 6: Surface debris at Teshekpuk Lake shore near well location – Summer 2006

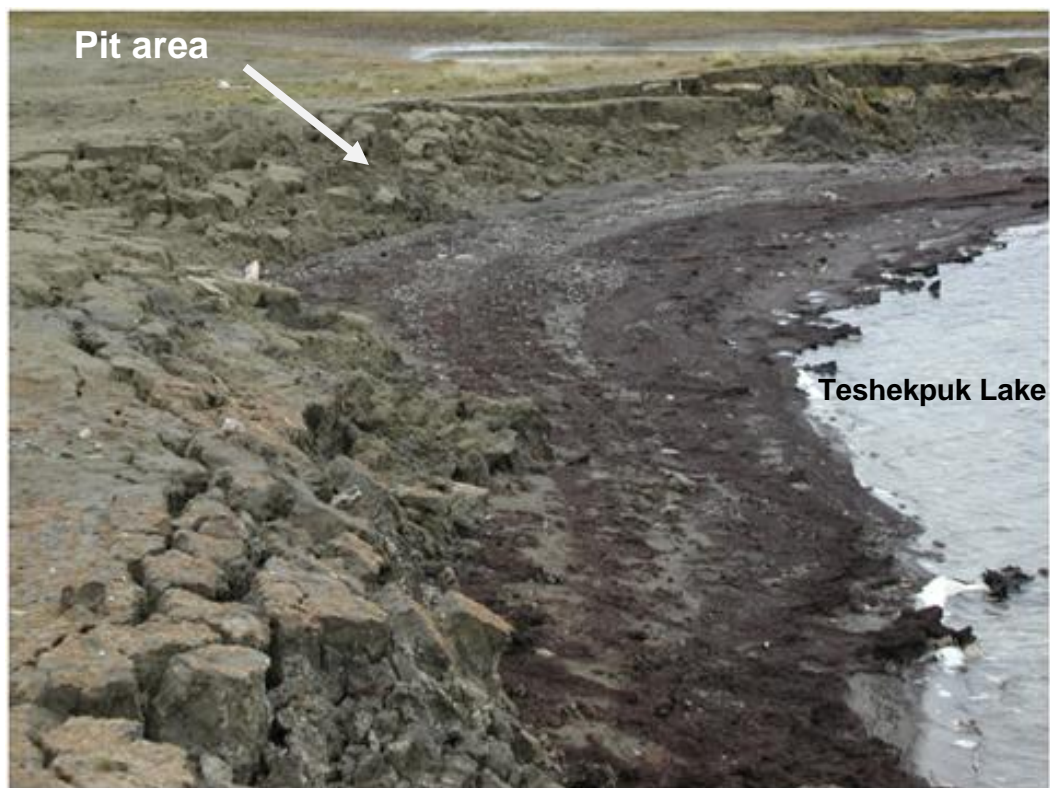
The well was drilled in 1976 on a small peninsula on the southeast side of Teshekpuk Lake as part of the USGS exploration efforts in the National Petroleum Reserve - Alaska. Due to its close proximity to the lake shore and prevailing winds, significant shoreline erosion had advanced into the well location requiring the BLM to complete plugging and abandonment of the wellbore and well site. The USGS had been actively using the well for permafrost temperature measurements prior to 2008. Diesel fuel inside the wellbore had been used as a non-freezing medium to aid in conducting the temperature measurements. During well plugging operations, approximately 9,240 gallons of diesel fuel was displaced with salt-saturated sea water prior to completing final plugging operations. Arctic Pac (diesel mud) was removed from the annulus and displaced with cement prior to setting the final surface cement plug.

Figure 7: Teshekpuk Lake shore erosion into well site and pit area – Summer 2006
